INSIDE A SOVIET ICBM SILO COMPLEX: THE SS-18
SILO DISMANTLEMENT PROGRAM AT DERZHAVINSK,
KAZAKHSTAN

John R. Matzko

Technical Report

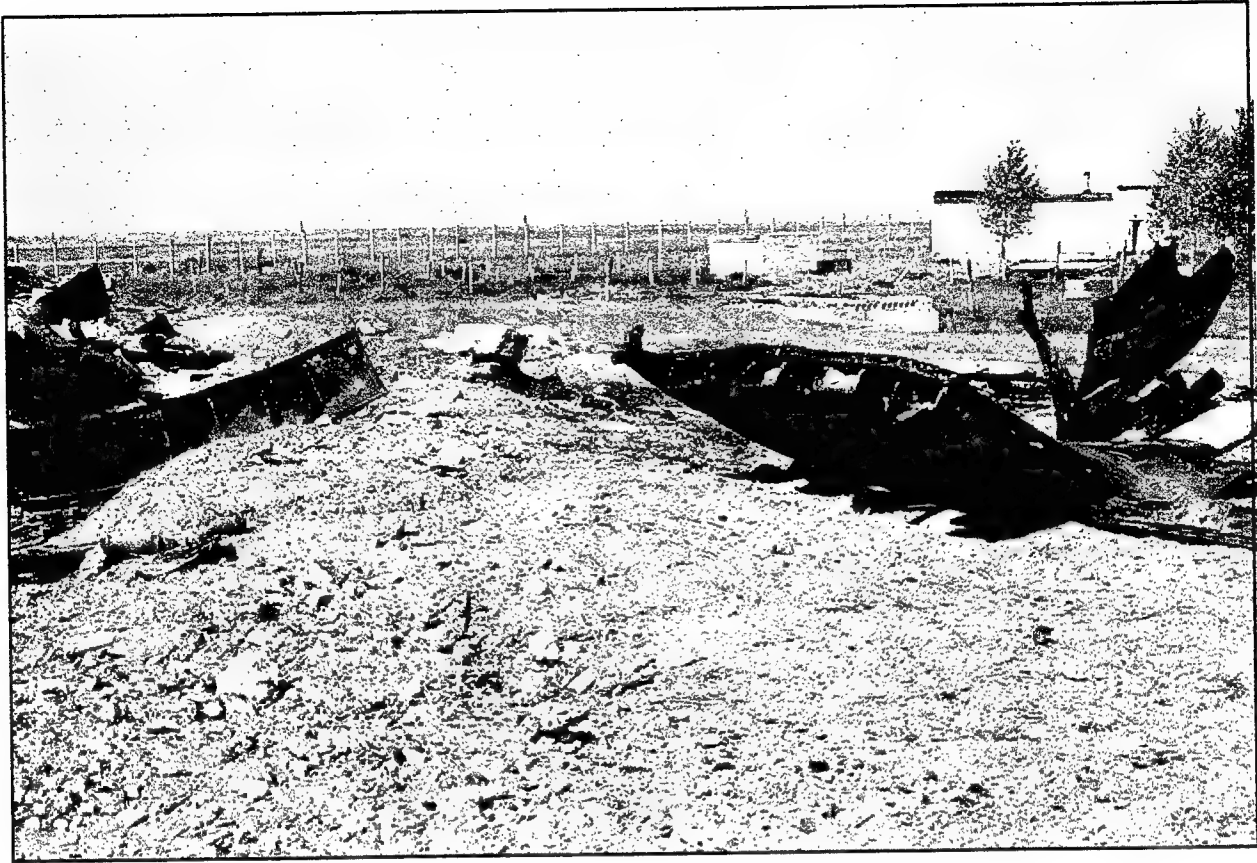
Figure 8. Metal and concrete debris on the crater rim. The ribbed metal plate on the right may be part of the headworks wall. The transformer substation is in the right background. Derzhavinsk, Regiment 2, Silos 5/7.

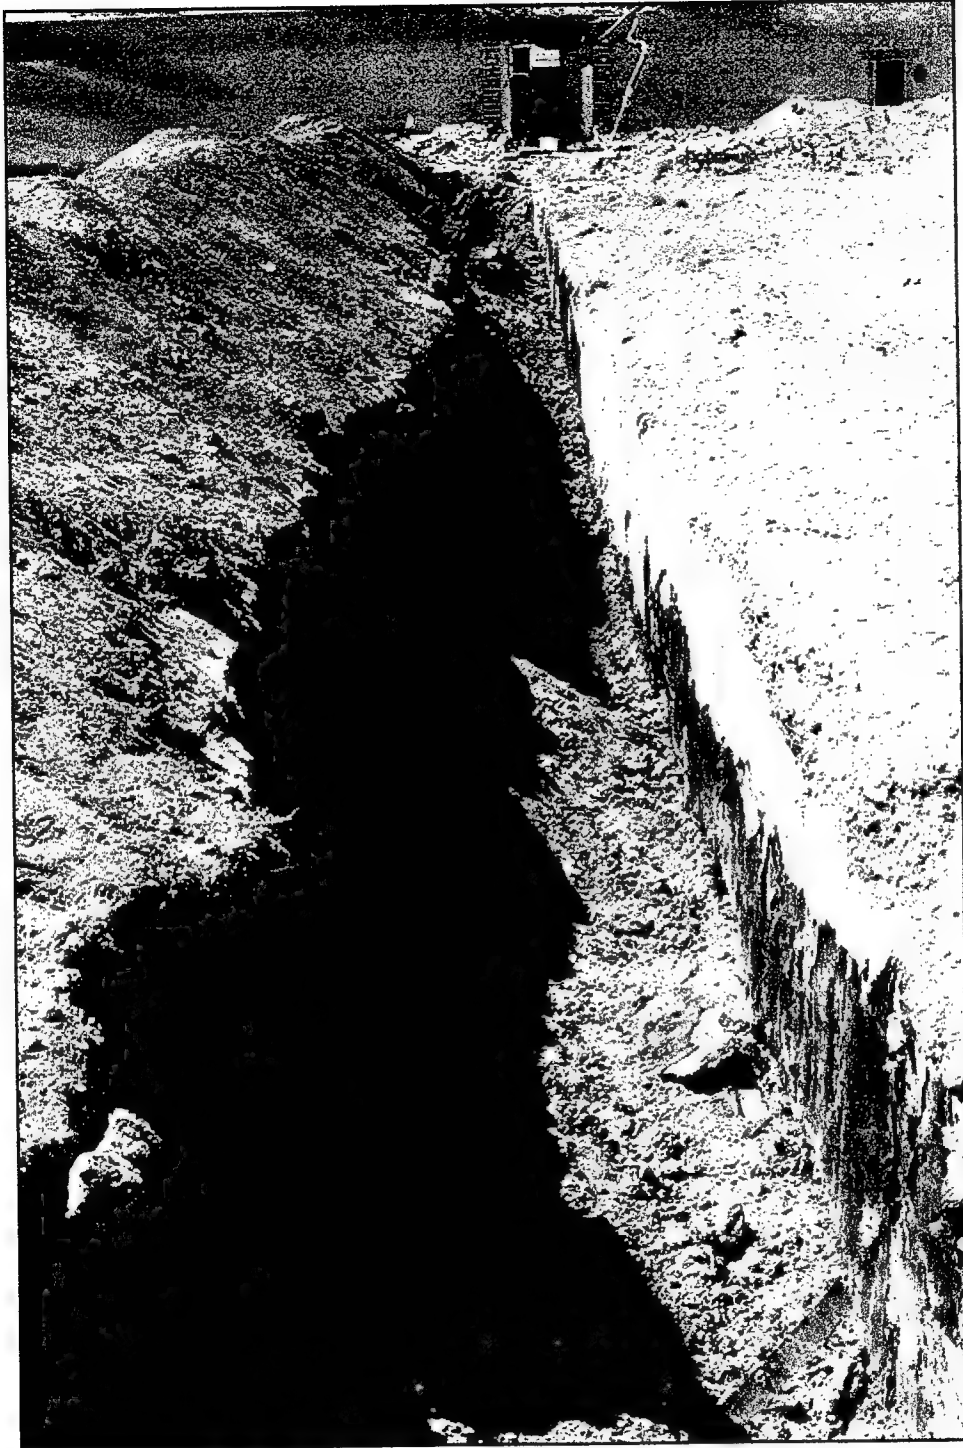
Figure 15. Partially excavated shallow buried tunnel between the cooling system building (in background) and the Launch Control Center (LCC) silo. Derzhavinsk, Regiment 3, Silo 7.

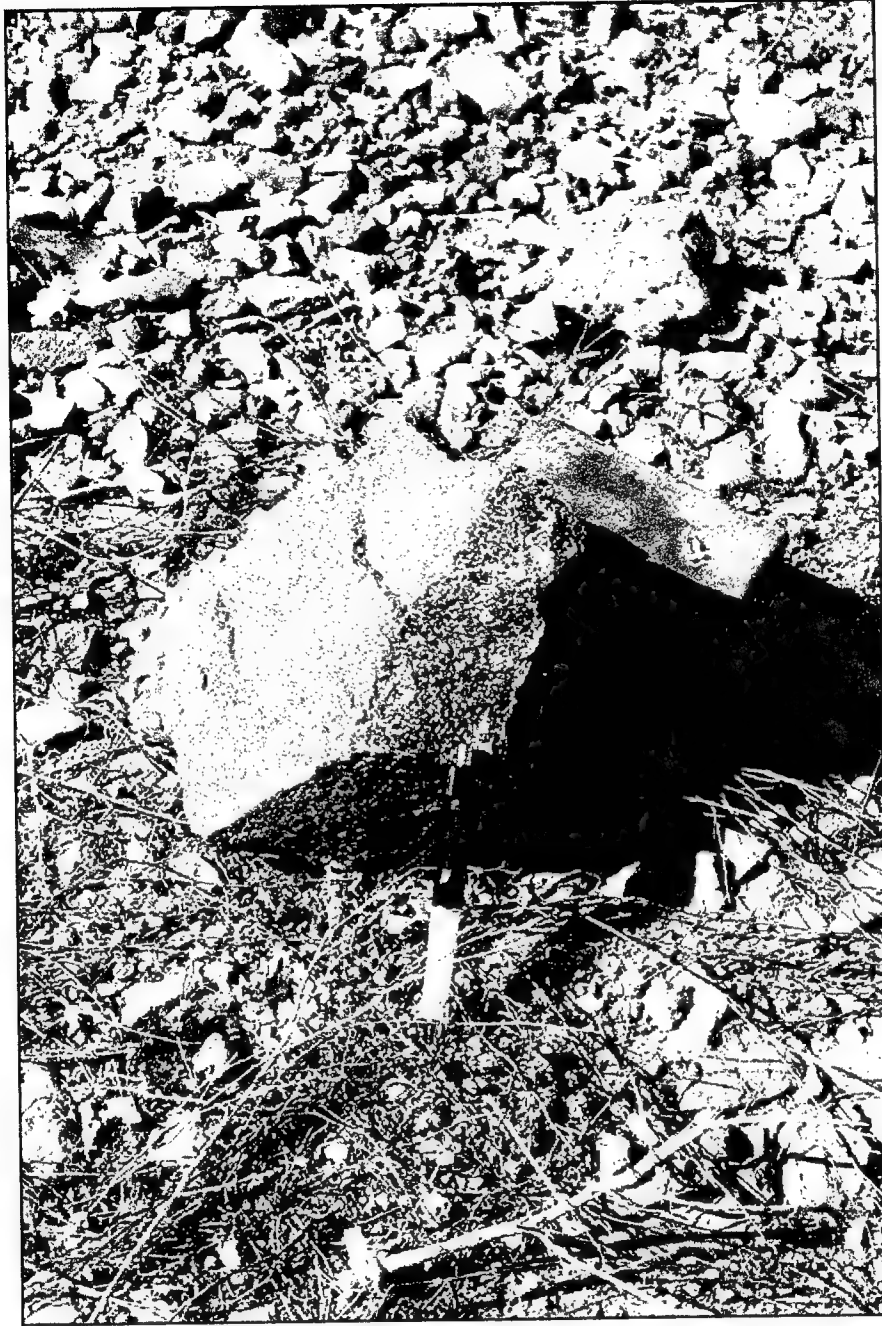
Figure 17. Fragment of a porphyritic igneous rock in the debris field around the crater. The rock has a dark matrix with white veins and crystals. The pen is six inches in length. Derzhavinsk, Regiment 2, Silos 5/7.

The debris that formed the crater rim around the headworks was composed mostly of silt, sand, clay and gravel. At co-located silos 5/7, Regiment 2, several large fragments of igneous and metamorphic rock were observed (Figures 17 and 18). The origin of these rocks is uncertain. The bedrock in the area of the Derzhavinsk base is composed of Paleozoic igneous rocks and Precambrian to Cambrian metamorphic rocks (see the section on Geology). It is possible that the fragments were excavated during the construction of the silo tube and added to the backfill, or the rocks may have been brought in from a quarry two or three kilometers east of the town of Derzhavinsk, and added to the backfill around the headworks. At least some silos appear to have been built up to about 1.5 m above the original ground surface and backfilled, possibly during modification of the original SS-9 silo to accommodate the larger SS-18 missile.

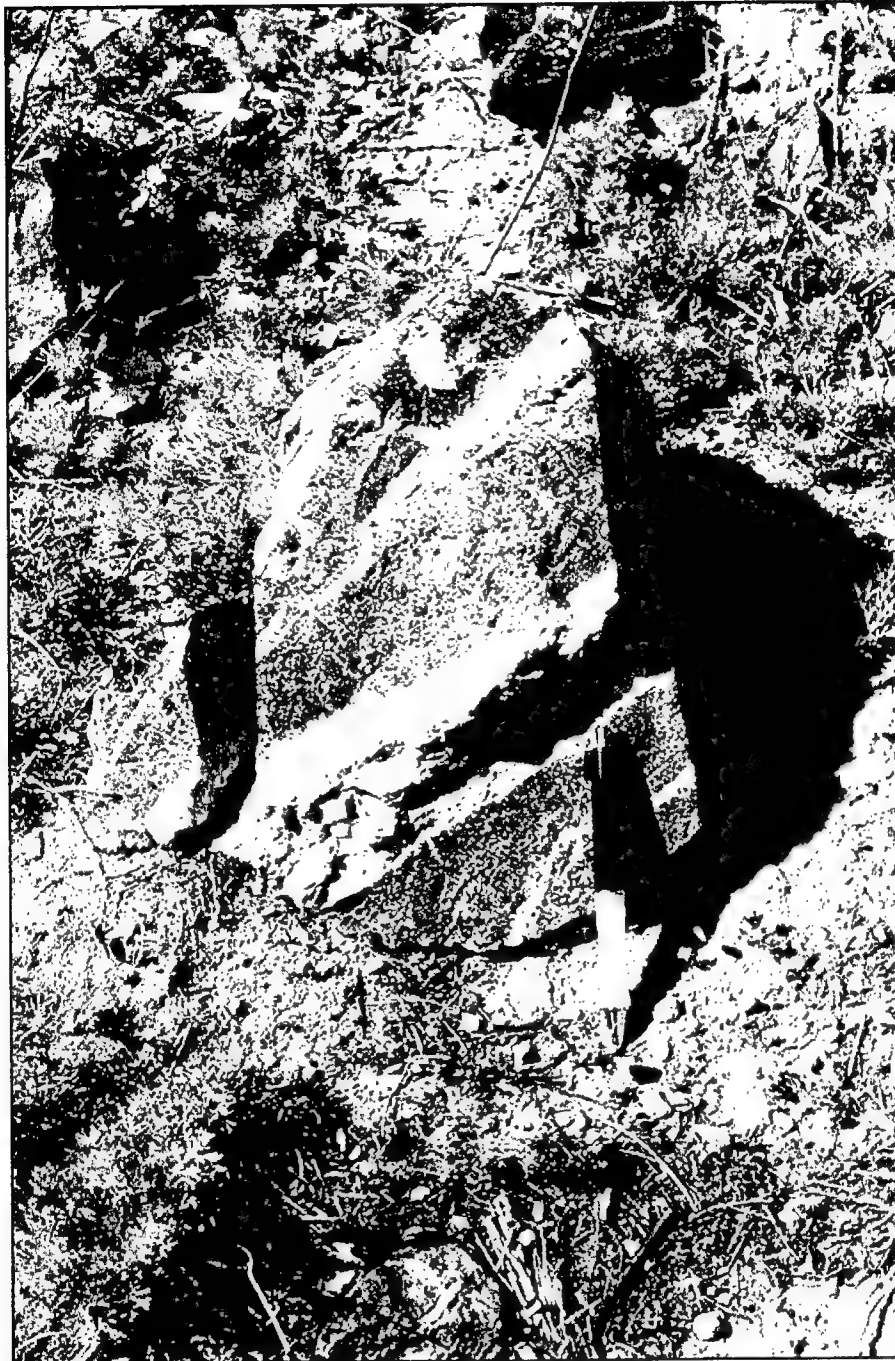
Figure 18. Fragment of banded igneous rock in the debris field around the crater rim. The pinkish bands intruding into the fine-grained matrix give a "gneissic" appearance to the rock. The pen is six inches in length. Derzhavinsk, Regiment 2, Silos 5/7.

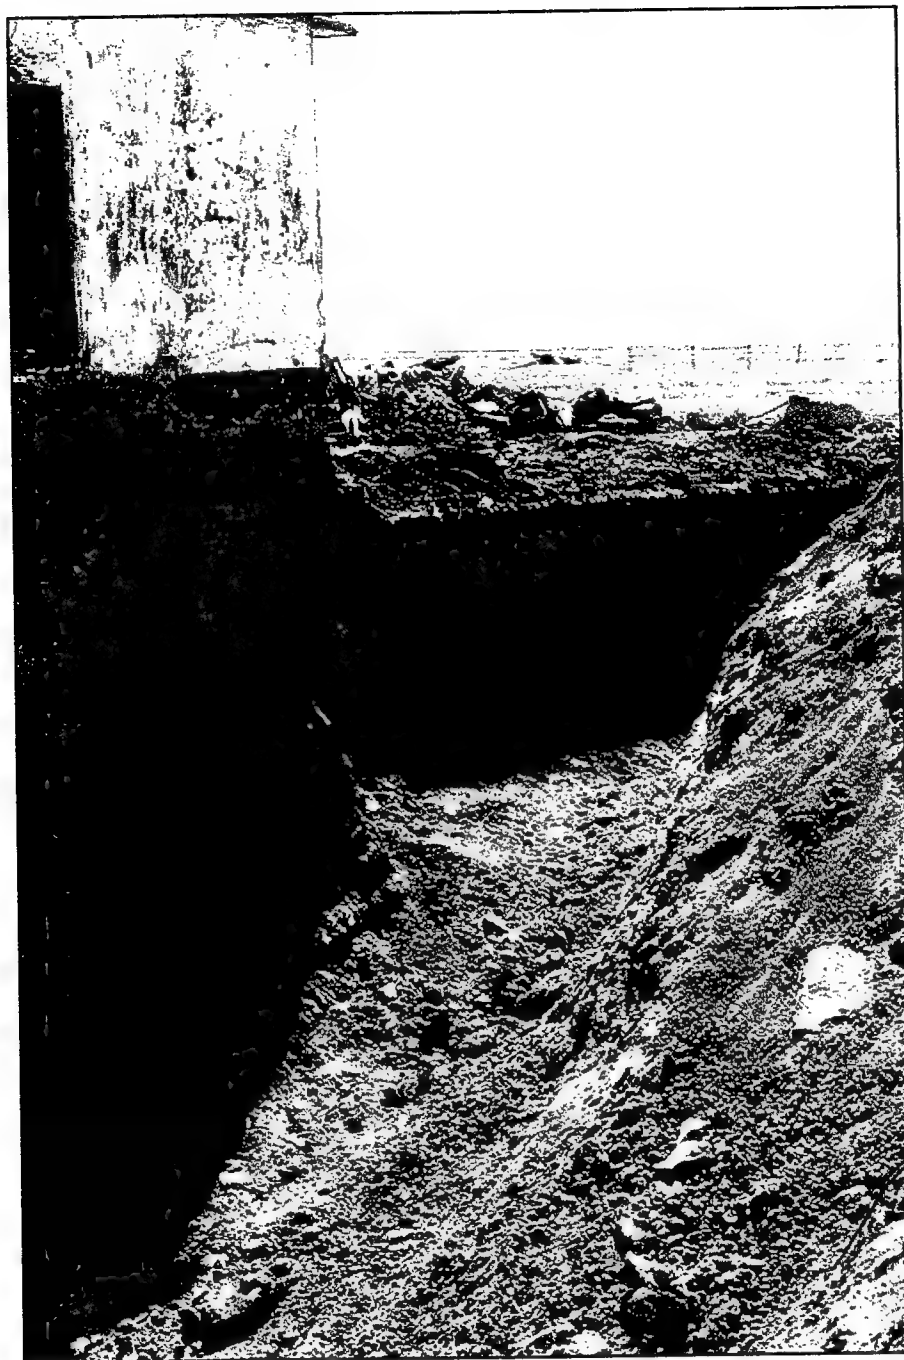
Figure 21. Trenching along side the "Force Protection" security building has exposed the subterranean level of the building and the associated shallow buried tunnel. The buried structures are lined with red clay brick. The excavation is about three meters deep in dry fine-grained silt and clay. Derzhavinsk, Regiment 2, Silo 2.

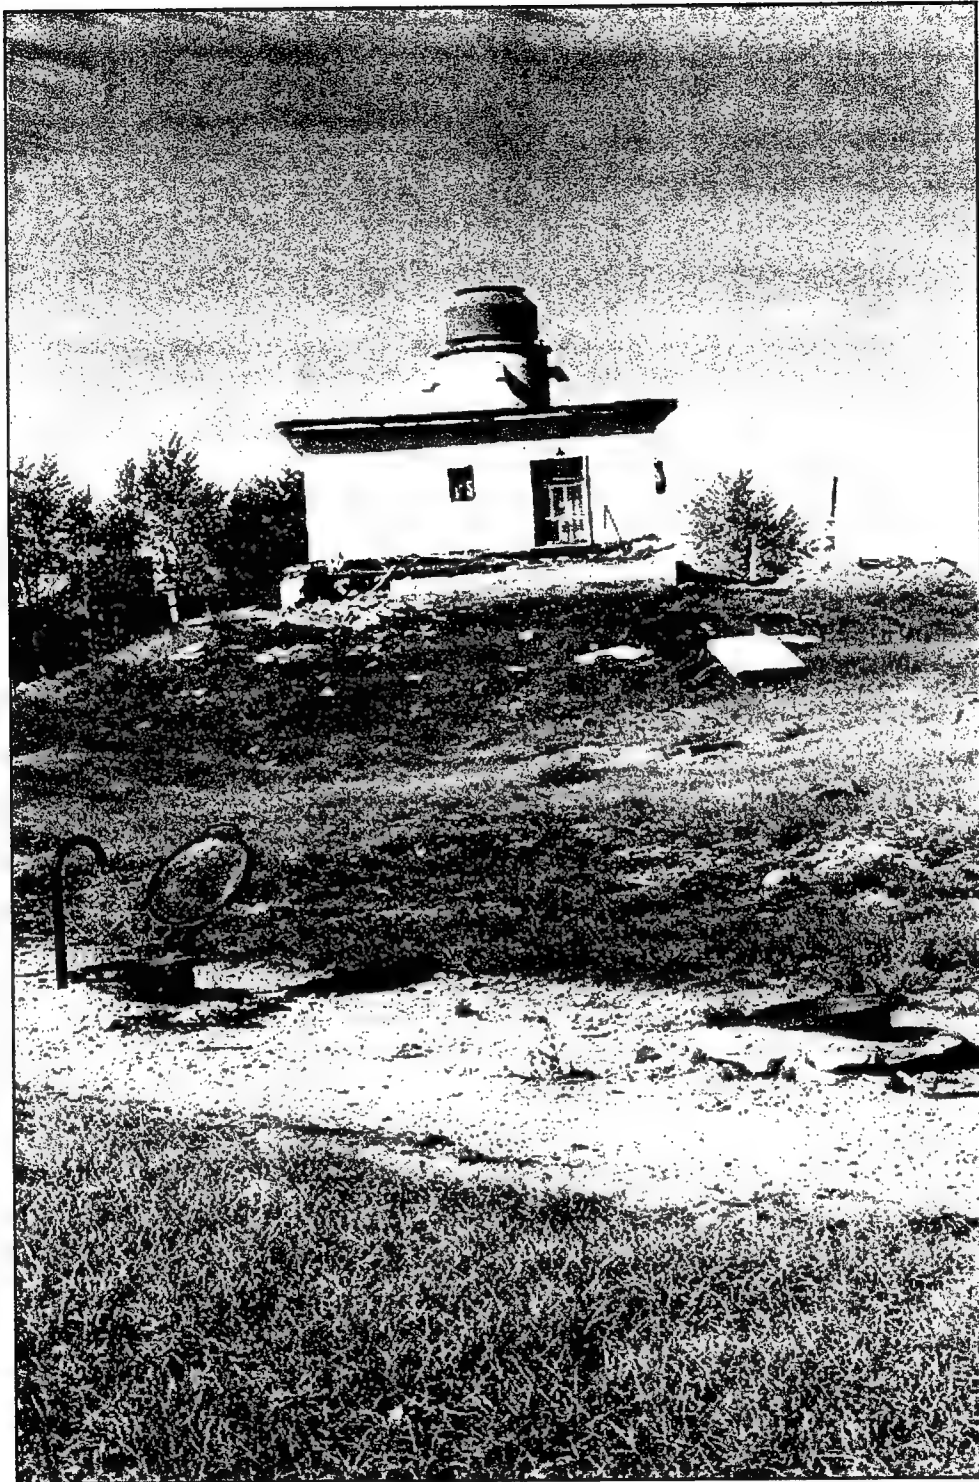
Figure 30. The "Force Protection" security building. The green metal dome on top of the building houses a rotating gun position. Buried diesel fuel tanks in the foreground. Derzhavinsk, Regiment 2, Silos 5/7.

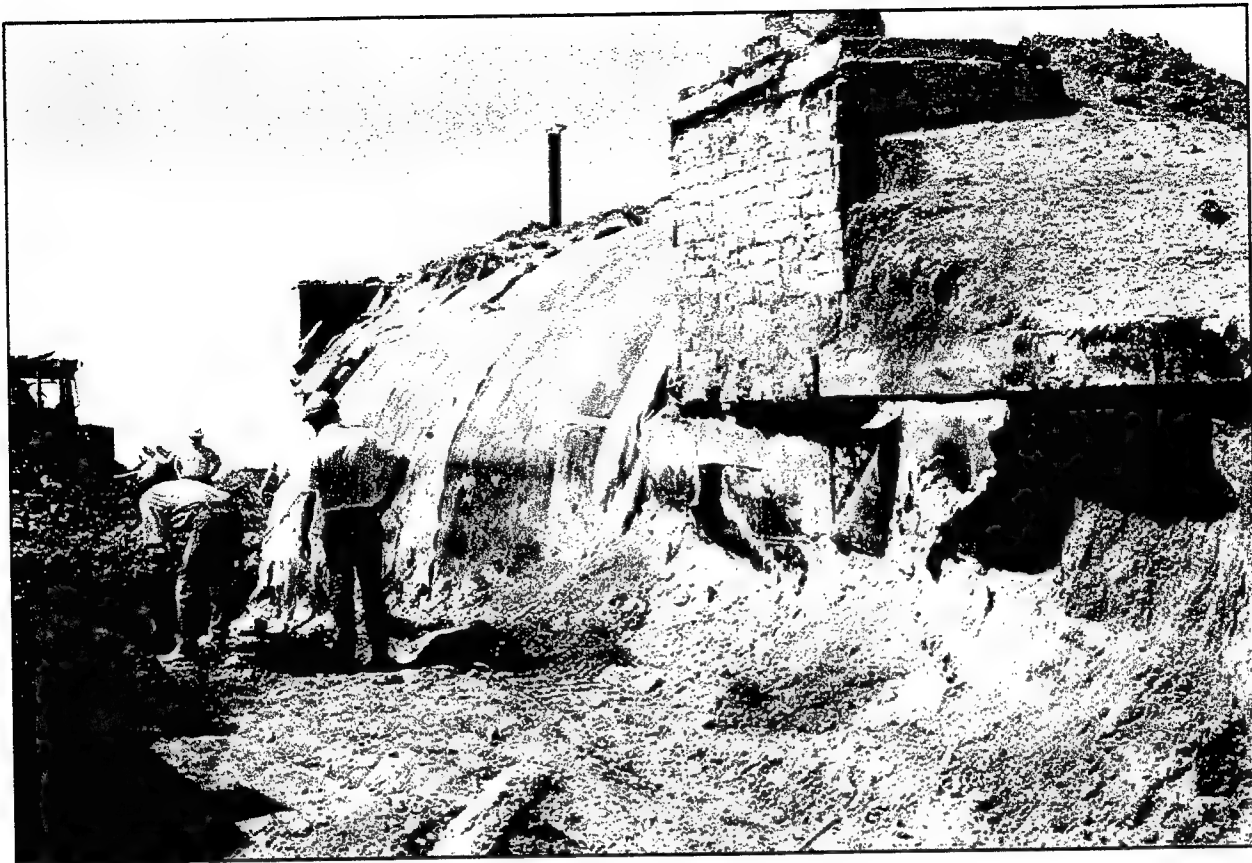
Figure 33. Bermed storage facility being exhumed for destruction and disposal. A black tar paper-like material covers the reinforced concrete. Derzhavinsk, Regiment 2, Silo 3.

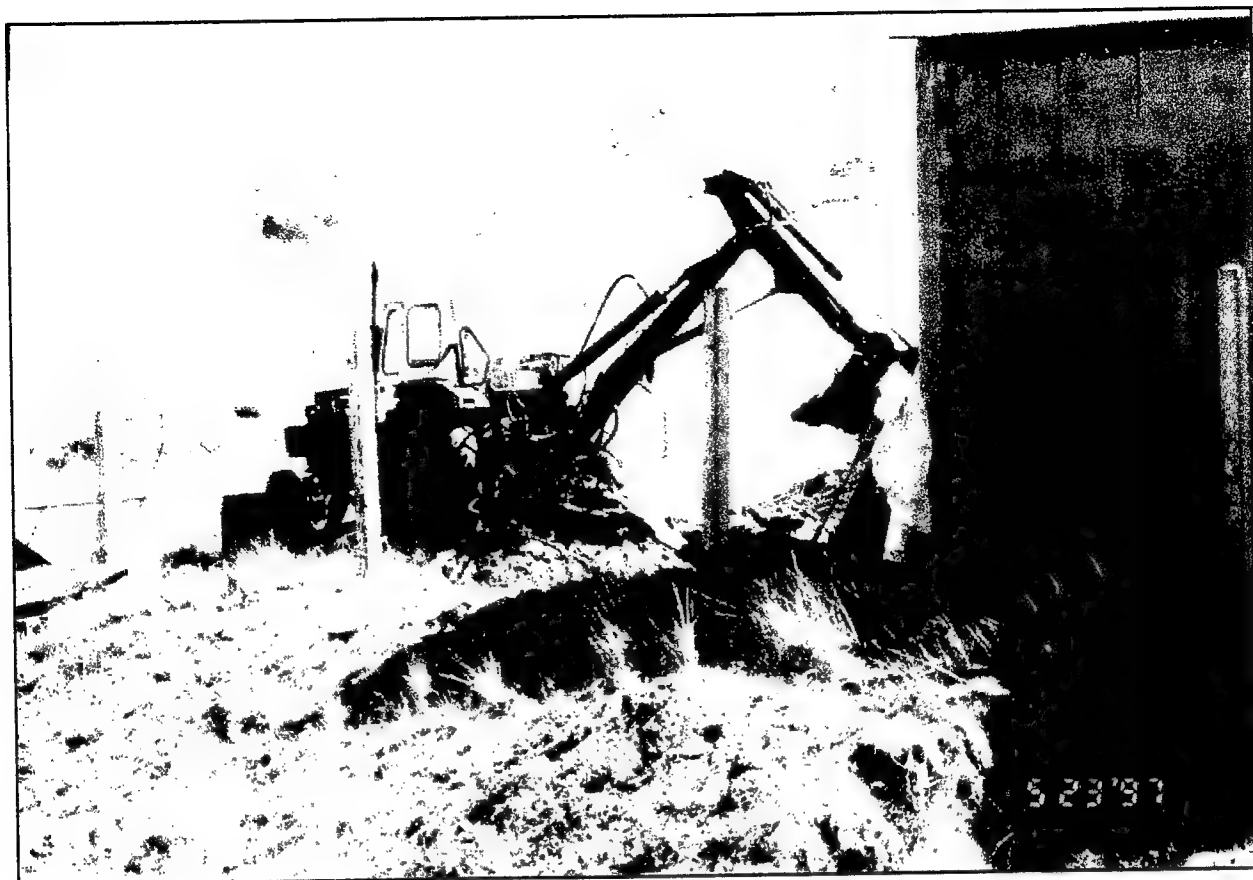
Figure 35. Abatement contractor crew removing PCB contaminated soil near a transformer building. Zhangiz Tobe. Photo courtesy of Brown & Root/ABB SUSA.

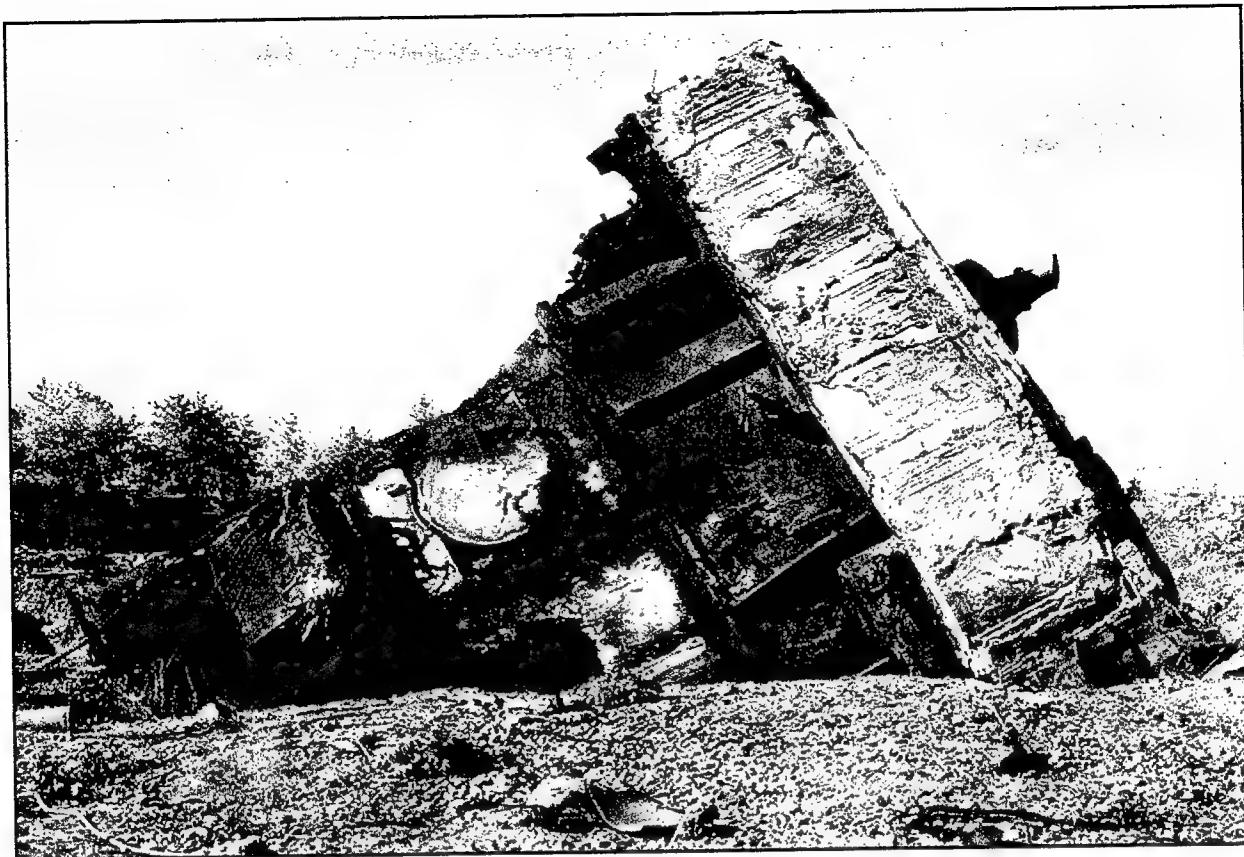
Figure 37. Relatively intact LCC silo door pocket still attached to part of the headworks wall.
Derzhavinsk, Regiment 2, Silo 7.

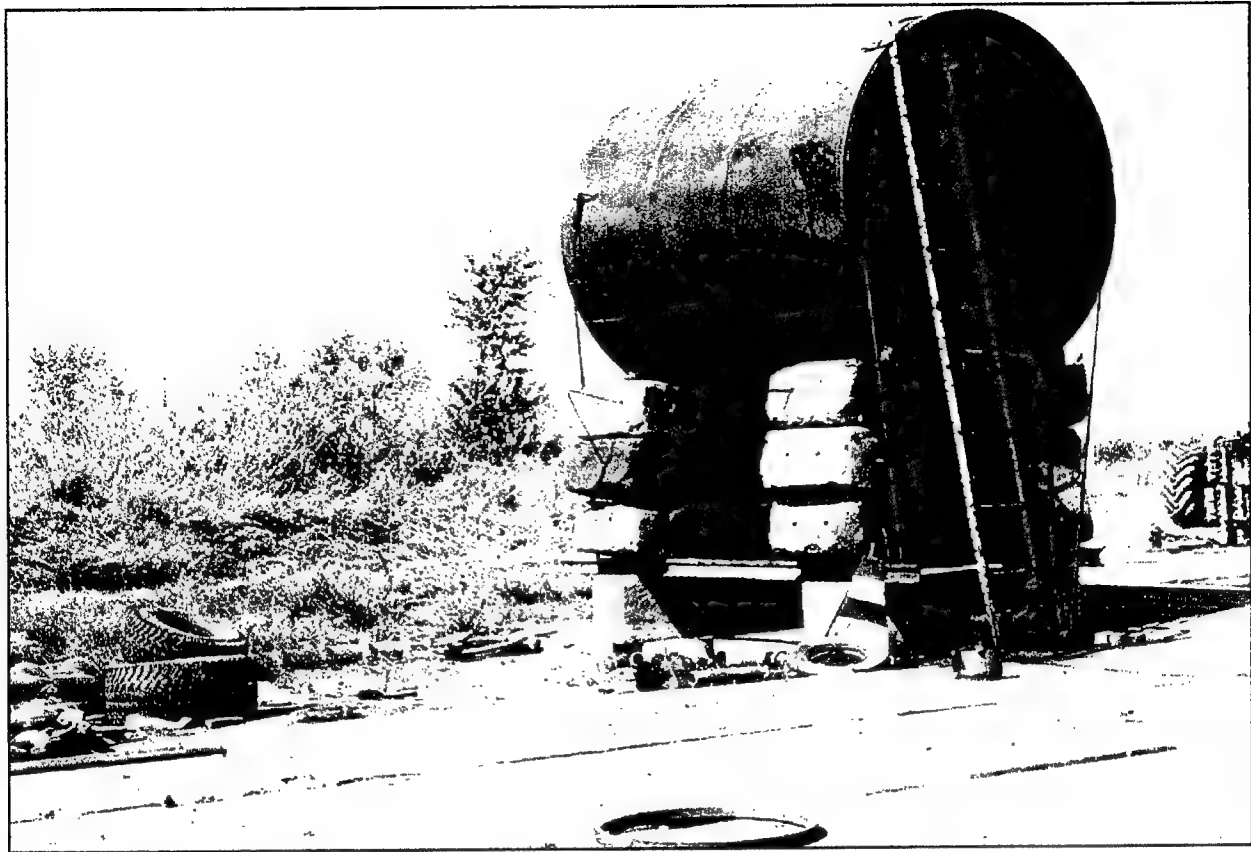
Figure 38. Salvaged sections of the "barbette" reinforced concrete walls used to support a water tank on a local farm. Note the salvaged concrete pads on the ground surface. Derzhavinsk.

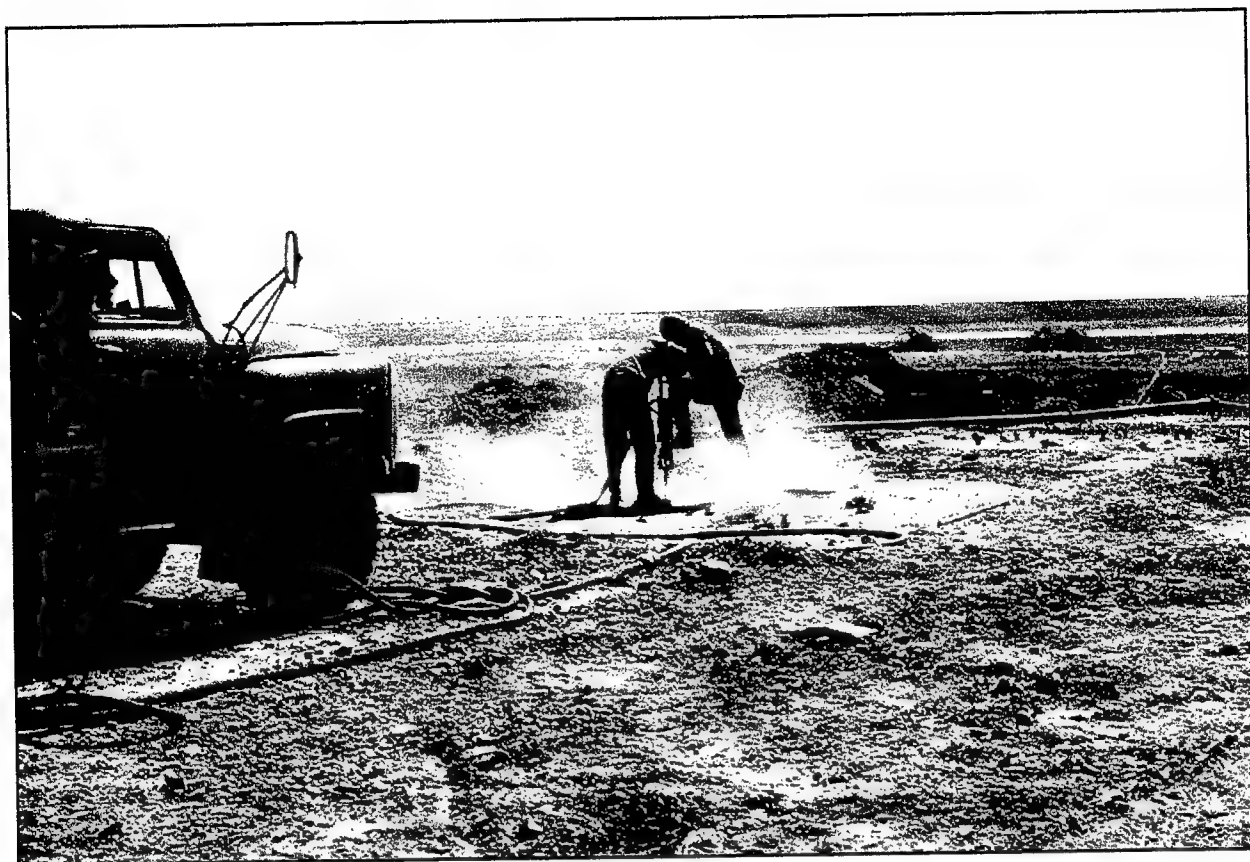
Figure 39. Drilling dynamite emplacement holes in the two-meter thick reinforced concrete support blocks of the transporter loading ramp. Derzhavinsk, Regiment 2, Silo 2.

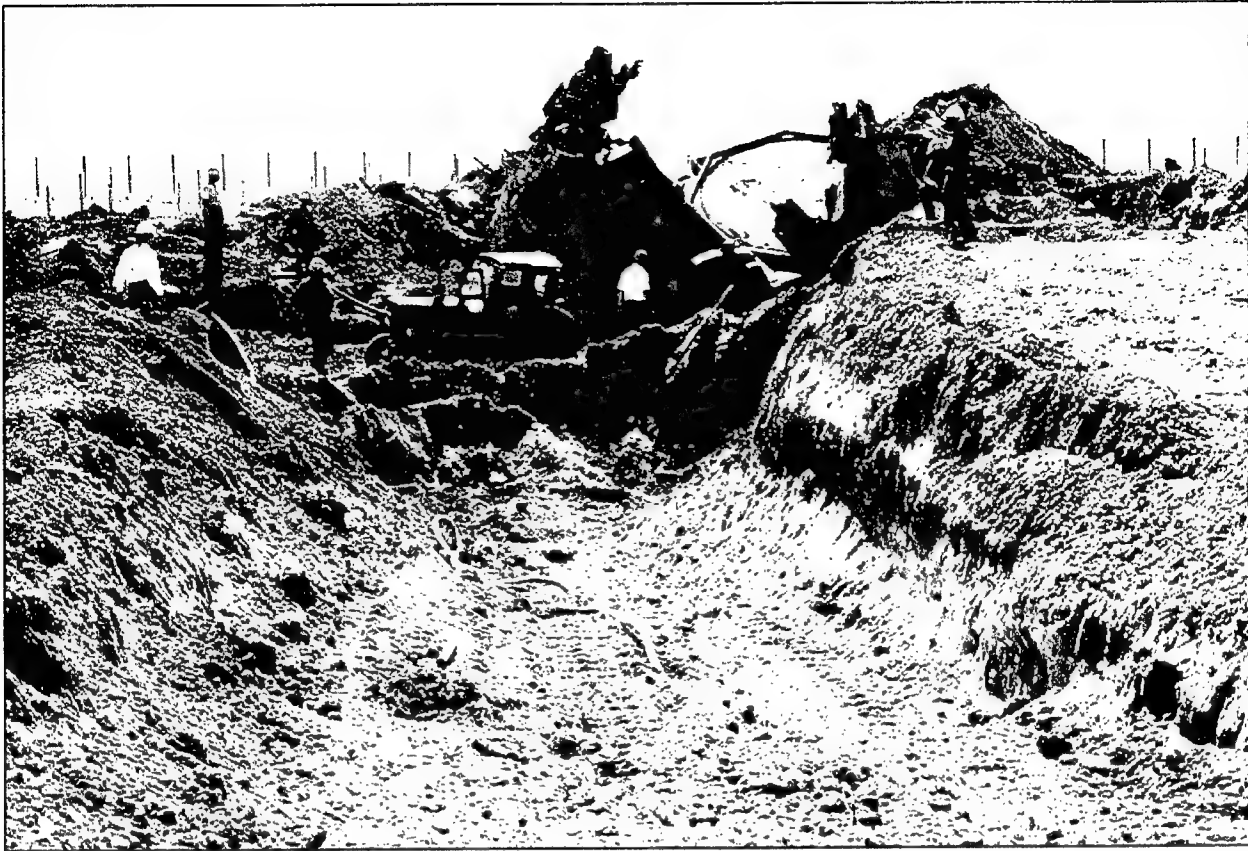
Figure 40. Ramp partially dug down to the silo crater for removal of metal and concrete, and backfilling of the silo tube with debris. The silo door pocket is on end. Derzhavinsk, Regiment 2, Silo 4.

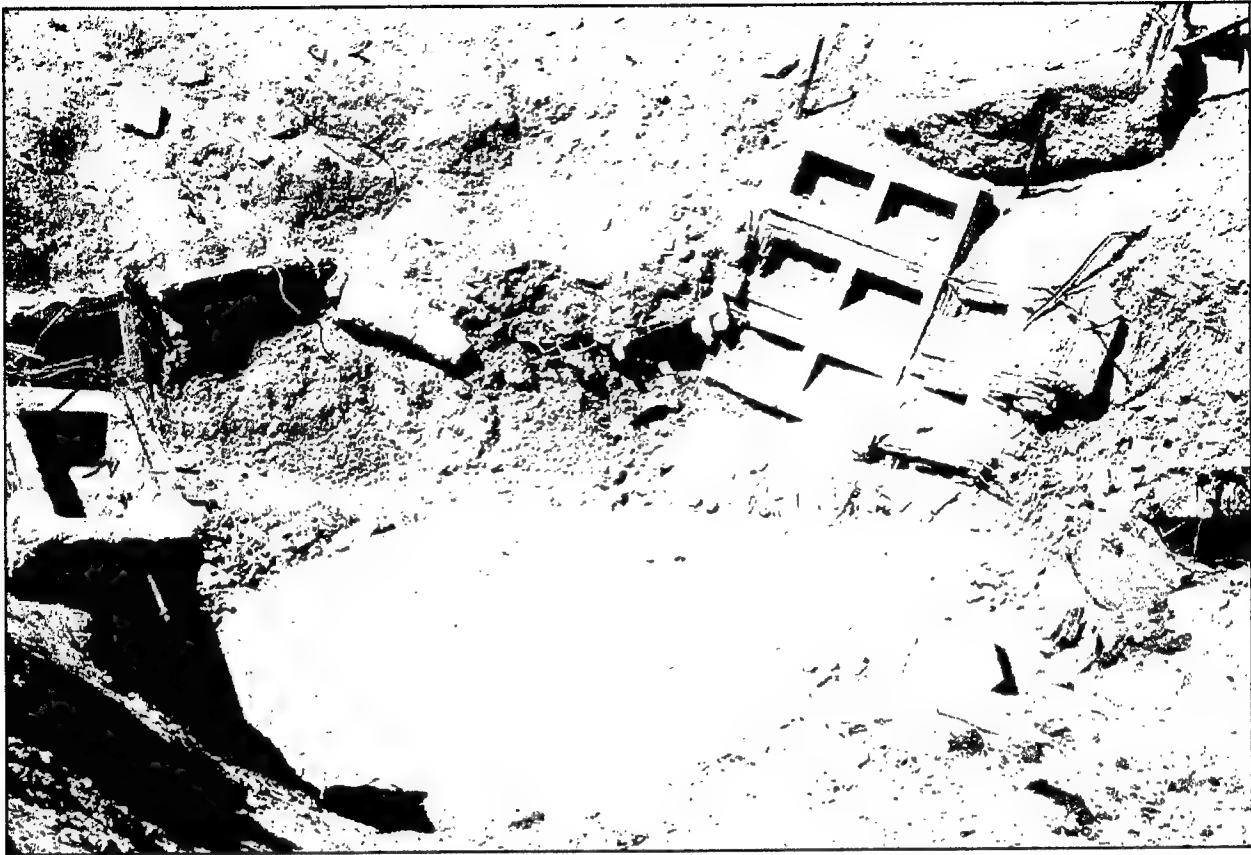
Figure 42. Poured reinforced concrete cap in place over the filled silo tube. Part of the "barbette" wall is exposed in the crater. Derzhavinsk, Regiment 3, Silos 5/7.

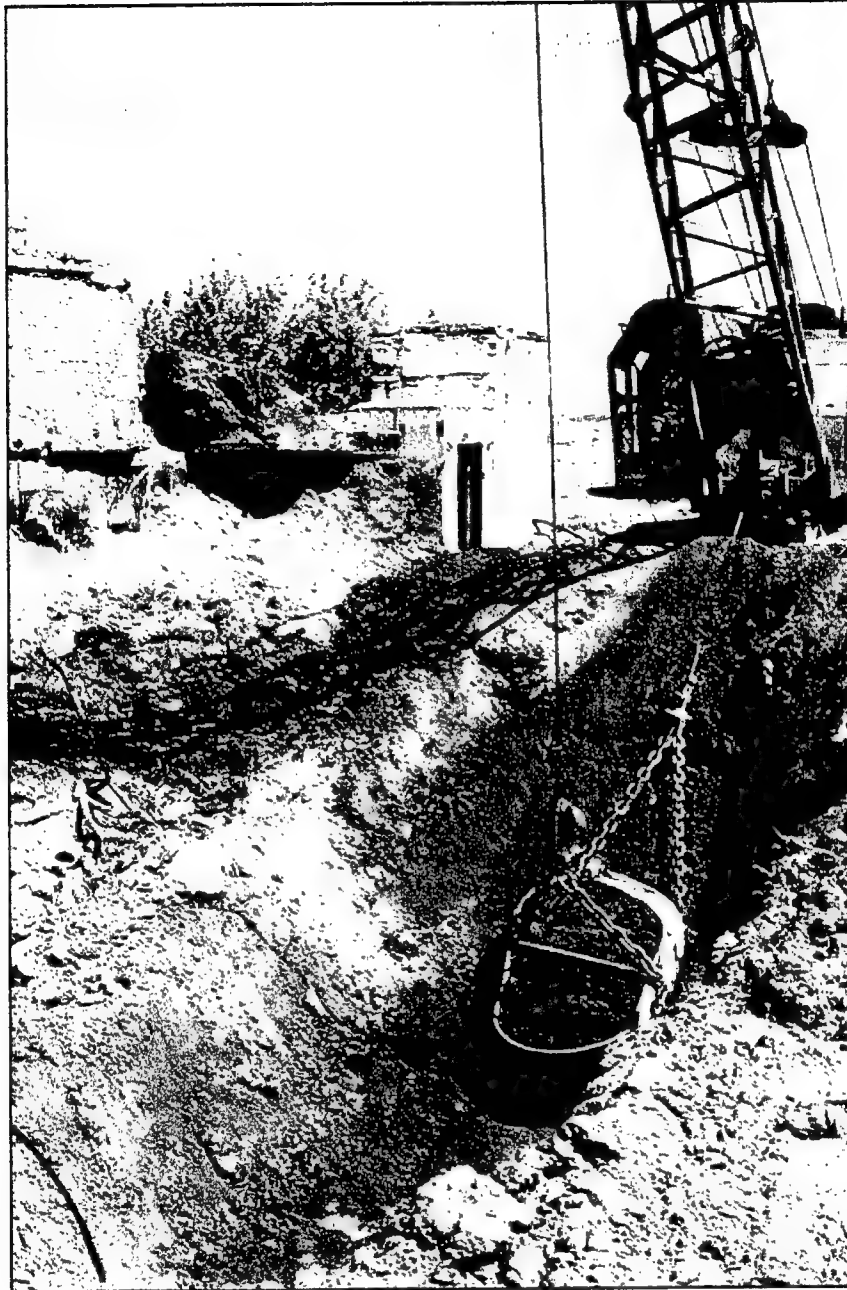
Figure 46. Excavating a pit along side a bermed storage bunker for the disposal of the bunker. The earth is brown, fine-grained silt and clay; the gray-white material is poorly sorted sand, possibly dumped in place during construction. Derzhavinsk, Regiment 2, Silo 3.

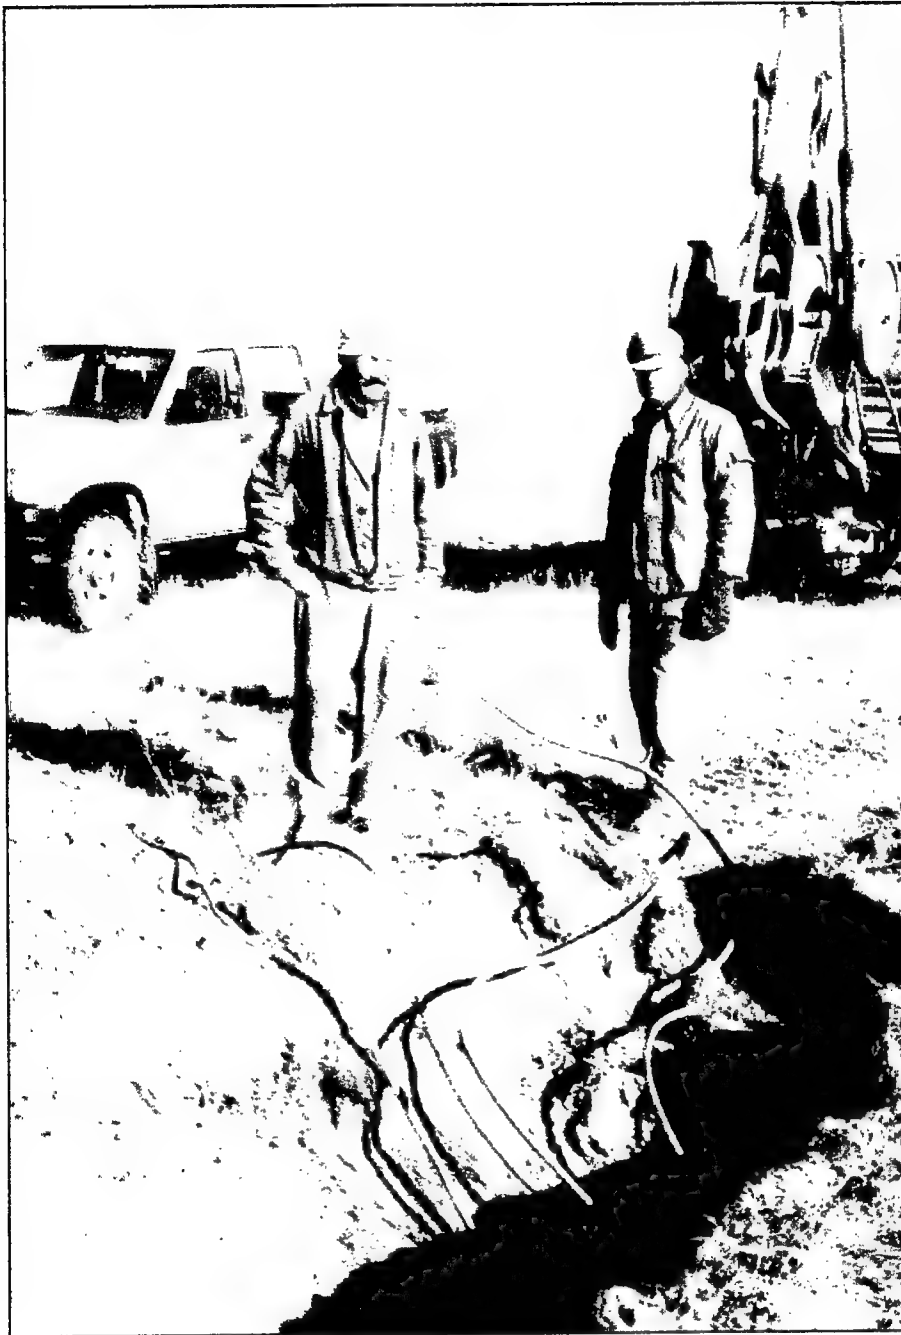
Figure 48. Cable salvaging operations. Four cables are being retrieved from one trench. Zhangiz Tobe. Courtesy of Brown & Root/ABB SUSA.
